Use of Tissue Patch sealant film for treating chylous leak after major neck surgery

Leo Cheng, Stuart Heaton, Gary Parker and all volunteer crew members

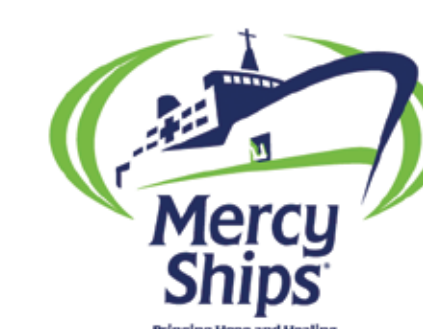
Homerton University Hospital **NHS**
NHS Foundation Trust

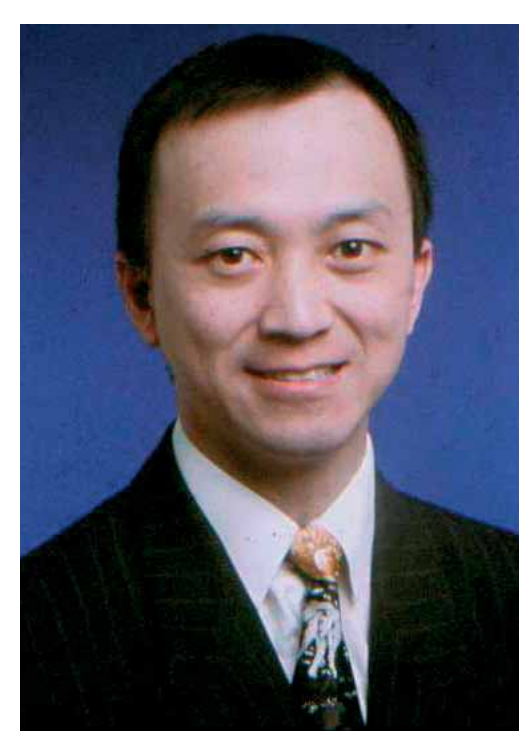
Chylous fistula is a rare but well recognized and serious complication following major neck surgery. Various medical management has been advocated to reduce chylous flow for low volume leaks and to maintain nutritional status. However surgical exploration is often required after failed medical management in high fistula output. We report the use of Tissue Patch sealant film on 2 patients as an adjunct to ensure an effective seal to potential sources of chylous leak.

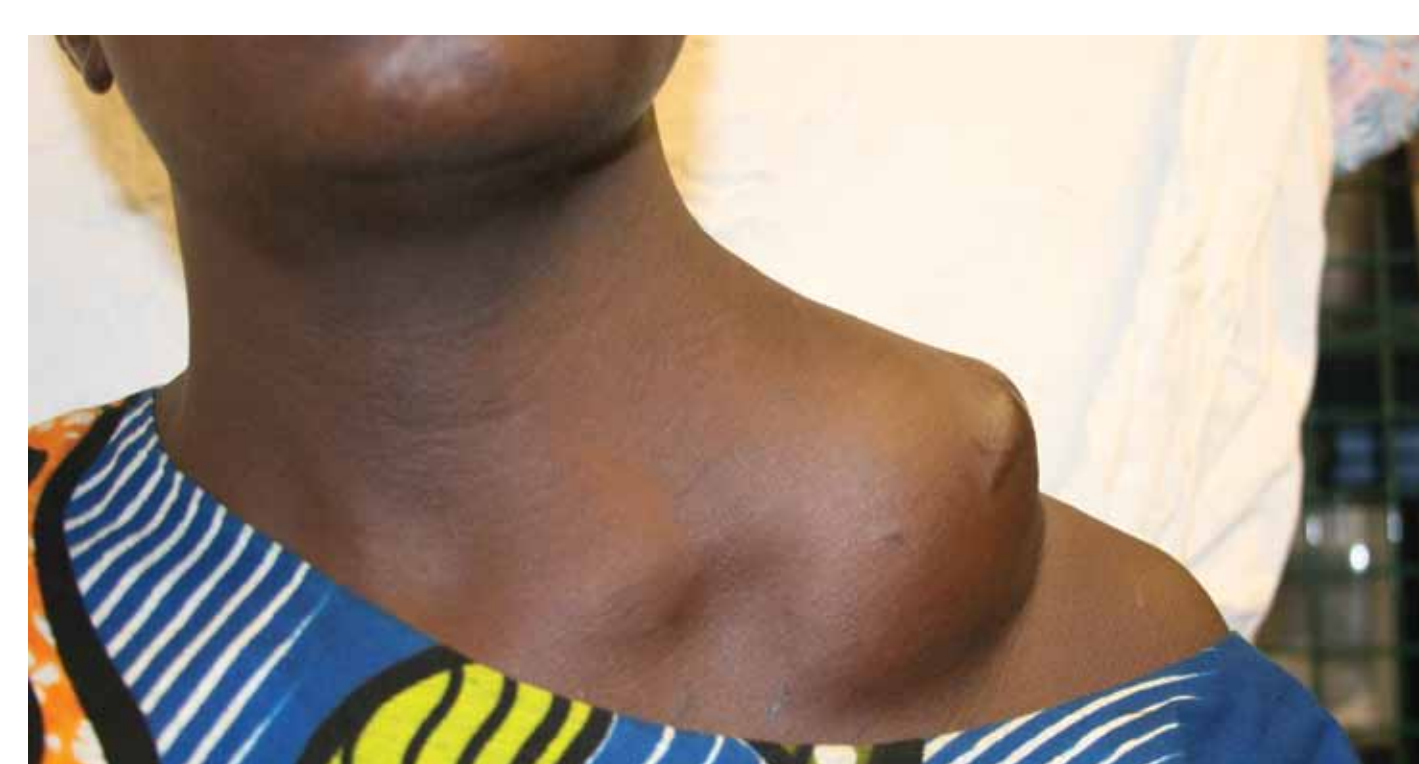
1. Large supraclavicular teratoma

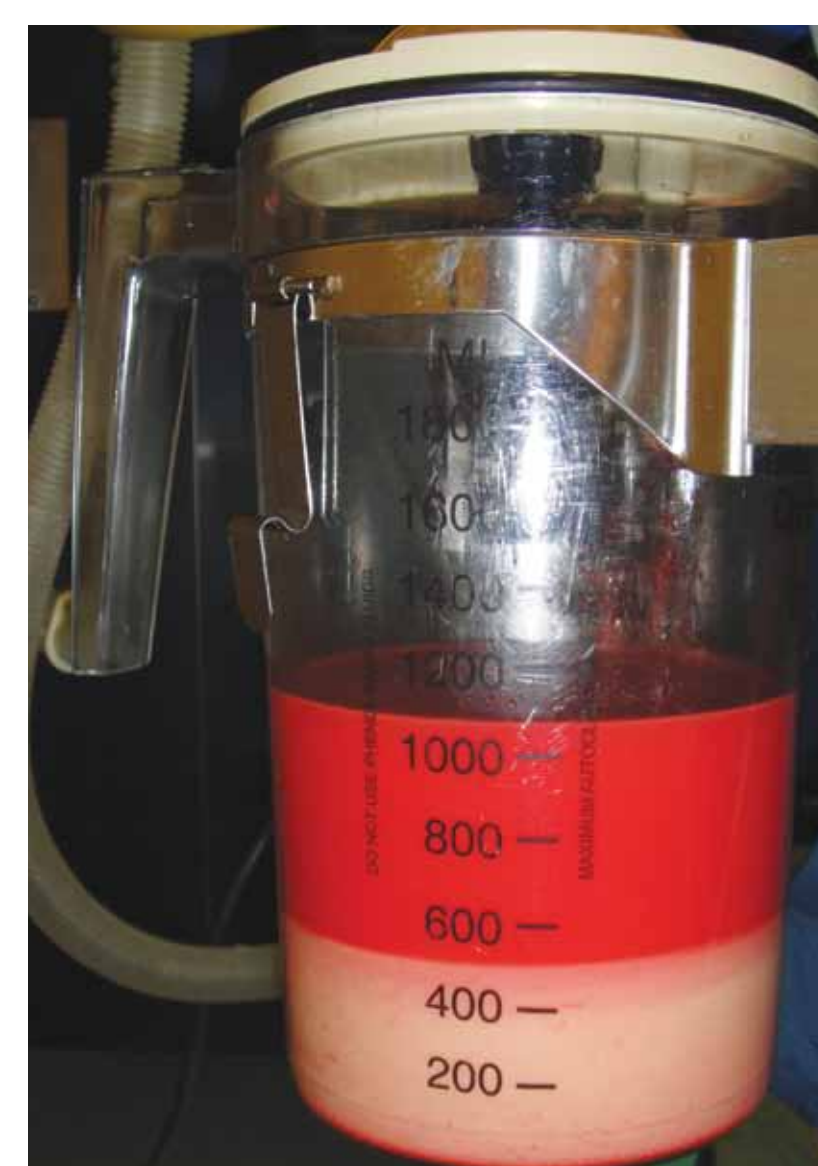
3. Initial drainage of chylous leak

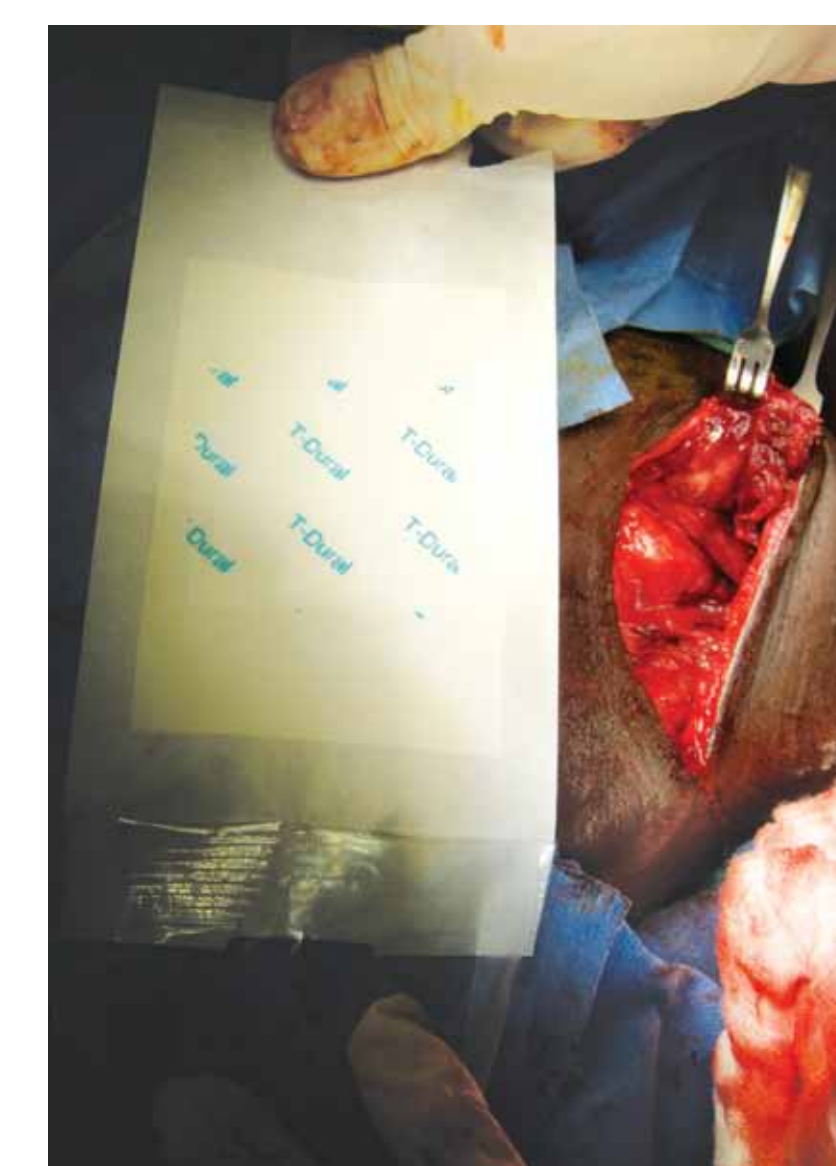
4. Tissue Dural was used to seal chylous leak after muscle flap repair

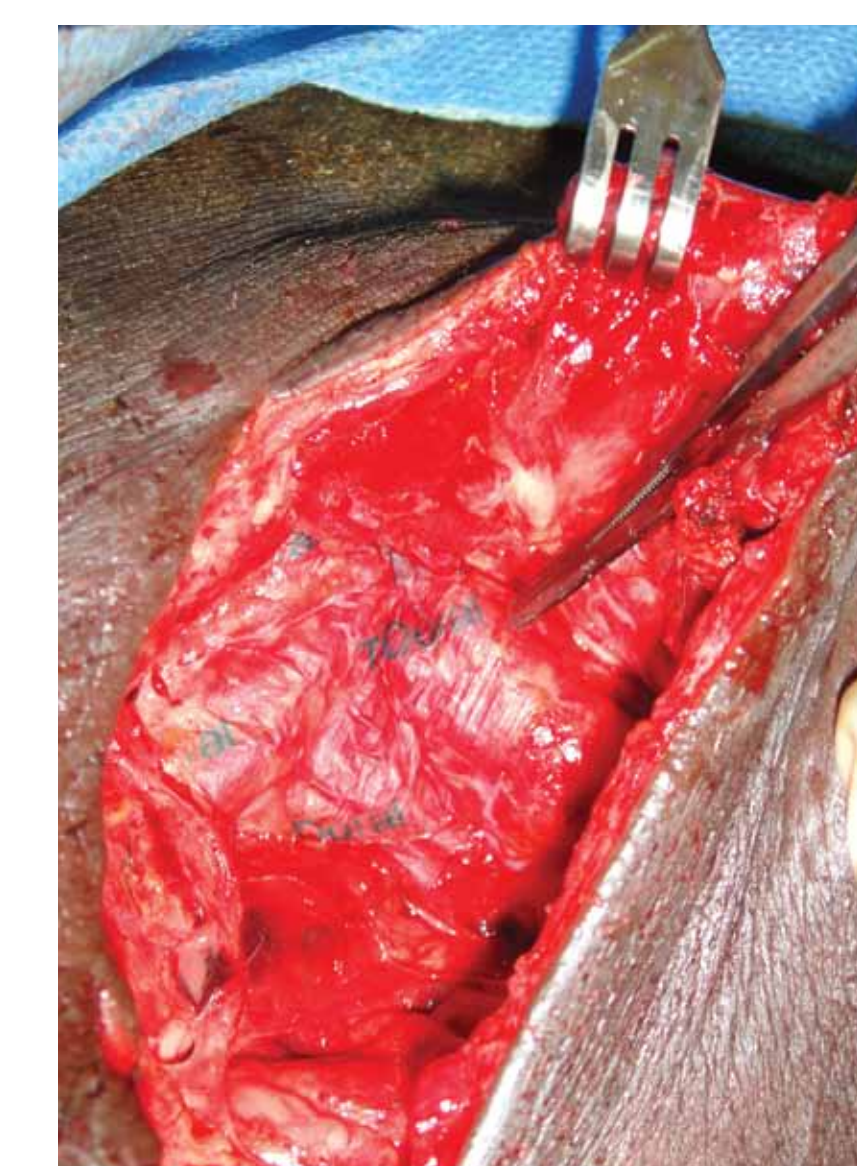
5. Methylene mark of Tissue Dural can be seen

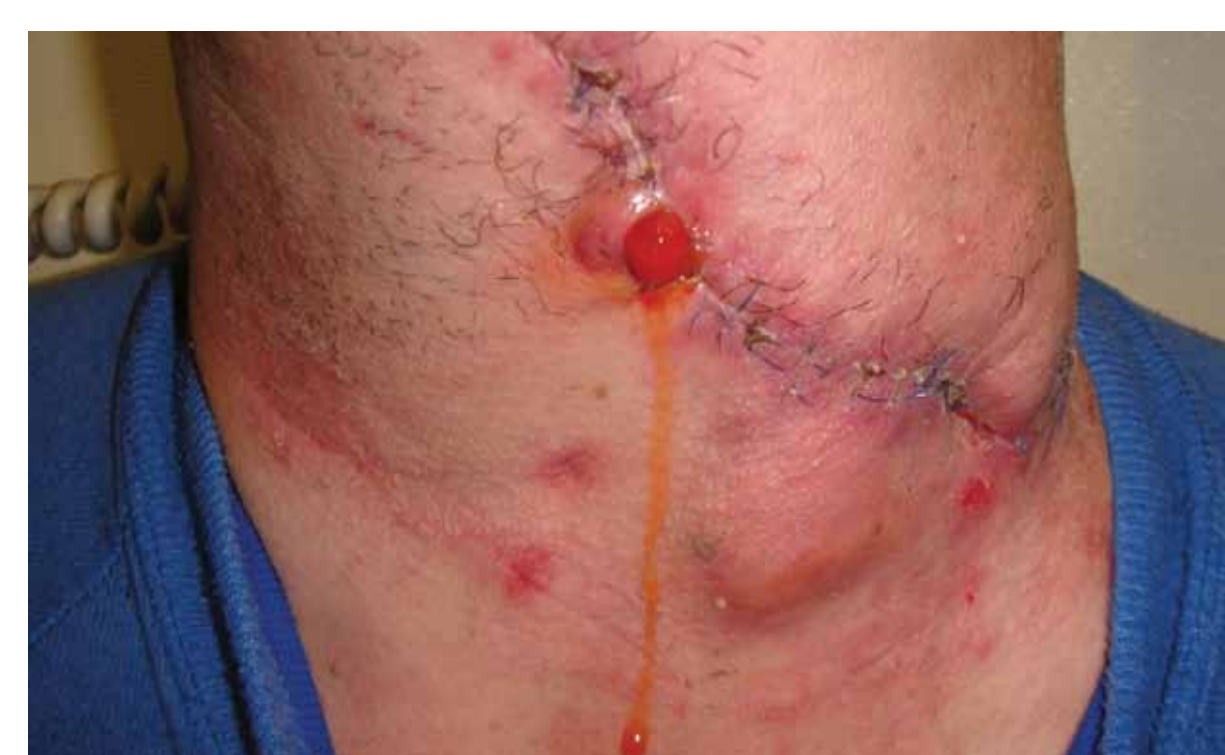
1. Chylous leak after neck dissection

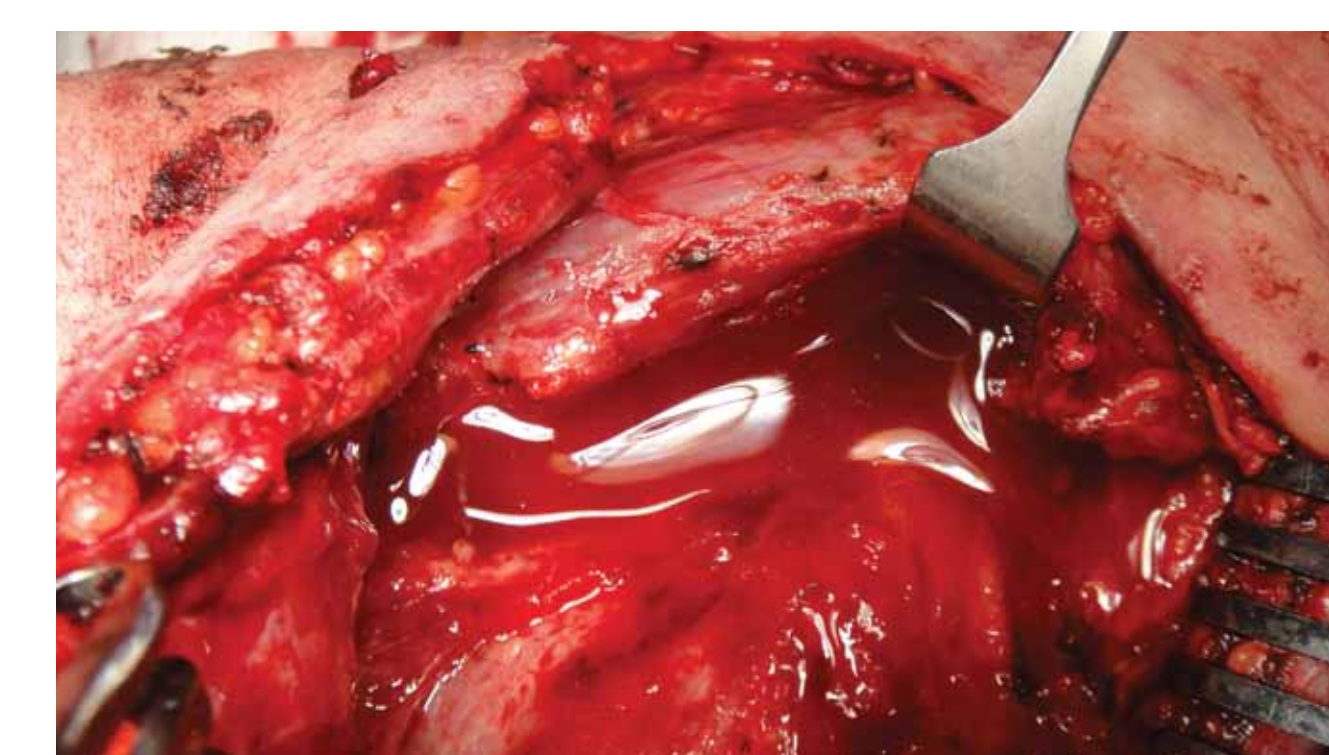
2. Re-exploration of neck revealed serous and chylous leak
